BRITISHROWING

Honorary Rowing Safety Adviser Monthly Report

October 2025

Stephen Worley

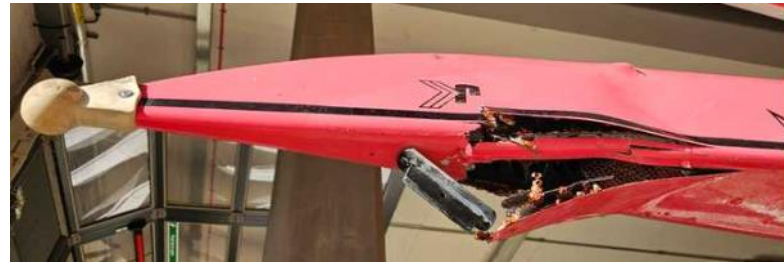
- A 4x rowed into the bank. The crew was reminded to look behind more regularly.
- In another incident, an 8+ hit the bank when a cox instructed the crew to easy rather than to hold it up. The bows of the 8+ were damaged (see photo).

Please remind crews to be aware that being in the correct place on the river is necessary but not sufficient to avoid collisions. It is also important to keep a good lookout.

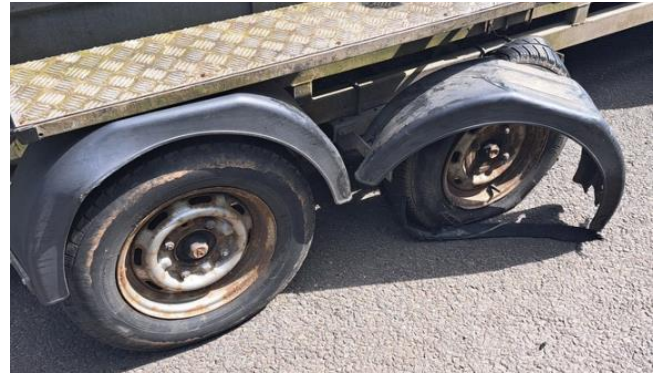
A trailer tyre suffered a total failure on the motorway. The incident occurred close to a junction, so the driver was able to leave the motorway and onto the hard shoulder of the junction slip road in a safe and controlled manner. The trailer had been serviced in January 2024, with no issues noted with the tyre, and the tyre itself was quite new, leading to the assumption that the incident was caused by a foreign object either at the scene, or previously in the journey.

The incident highlighted the lack of some key equipment within the towing vehicle. The lightweight warning triangle kept getting blown over by passing vehicles. The stopping location was on a slight bend, so a warning sign was essential.

The club resolved to provide: -

- Hi Vis vests for all occupants of the vehicle.
- A method of lifting the trailer to remove and replace wheels.
- A torch in case of an incident happening in darkness.
- A more robust warning triangle, which stays in place.
